## **IED Report**

#### **SIGACT Report**

TITLE: (EXPLOSIVE HAZARD) IED EXPLOSION RPT (Directional IED) 2/B/2-8

TRACKING NUMBER: 20111114092038SNA0132647260

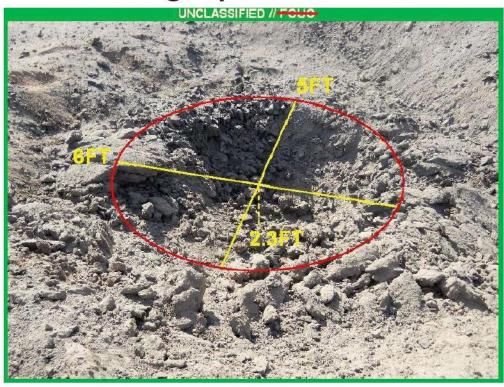
SOUTH FROM GRID 38S NA 01480 46977
